Impact 2010 – Paper US052 – Revised 11/4/10

Title: The role of moisture in red color formation and delamination, including the Root Cause, Mechanism and Prevention.

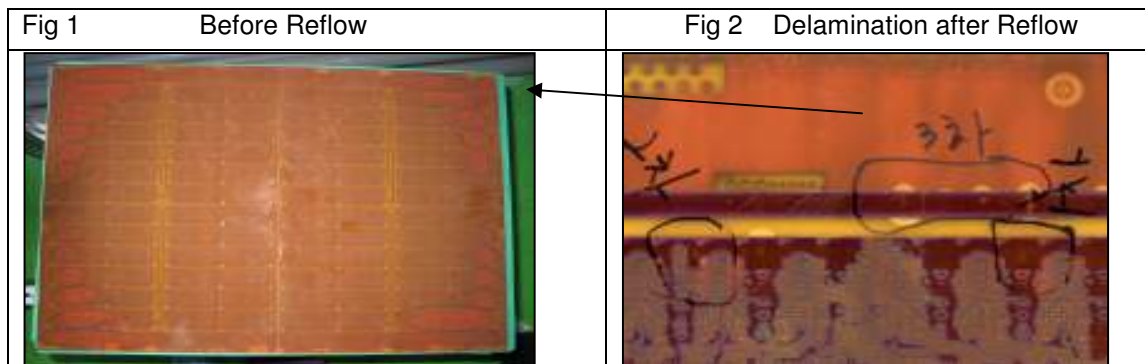
- Typically the red color change appears around the outside edges of the panel, suggesting a concentration of moisture as it was squeezed out to the edges during vacuum lamination (Fig 1). Delamination of red color areas was usually evident after reflow, in the same red color edge areas (Fig 2).

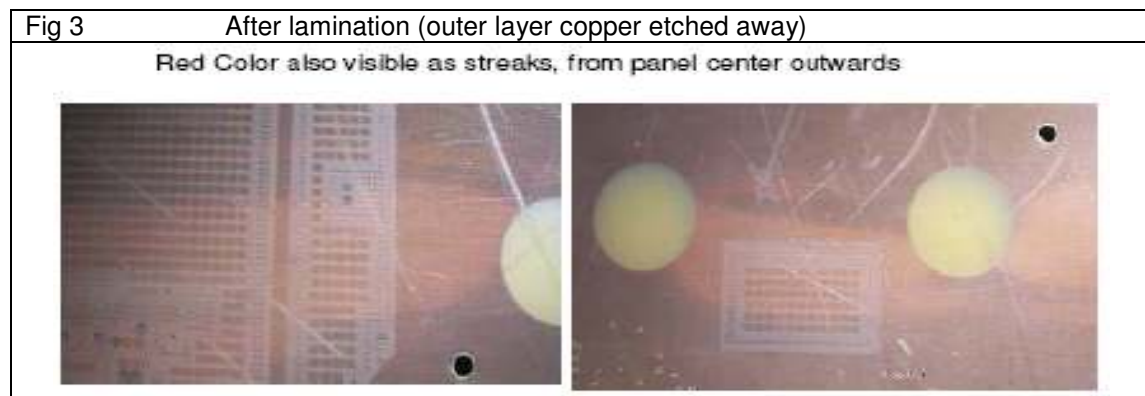
- Very often the red color change was seen as streaks “flowing” out to the panel’s edges after lamination. The red color streaks appeared to originate from large etched areas, indicating some outgassing from the laminate material (Fig 3).

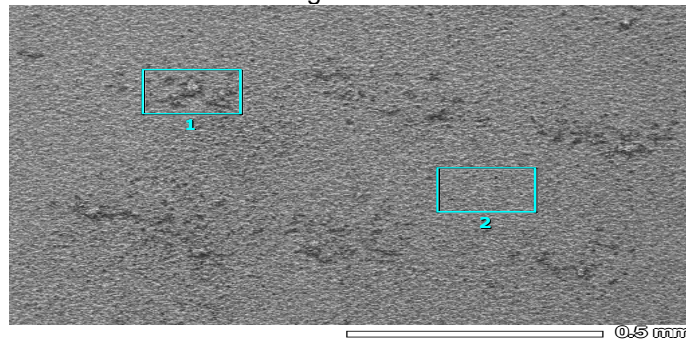
Fig 4

- SEM/EDS examination of premature delamination failure areas after reflow, indicated higher than normal levels of bromine in those areas (Fig 4 & 5).

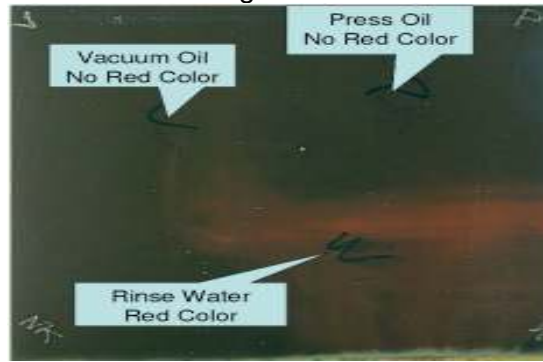
Fig 6

- An initial indication that trapped moisture was indeed the root cause when prepreg was contaminated with press oil, vacuum oil and rinse water from the press plate scrubber. 2 ml of each were placed on the inner layer core under the prepreg, before lamination. Only the area with rinse water exhibited a red color change (Fig 6).

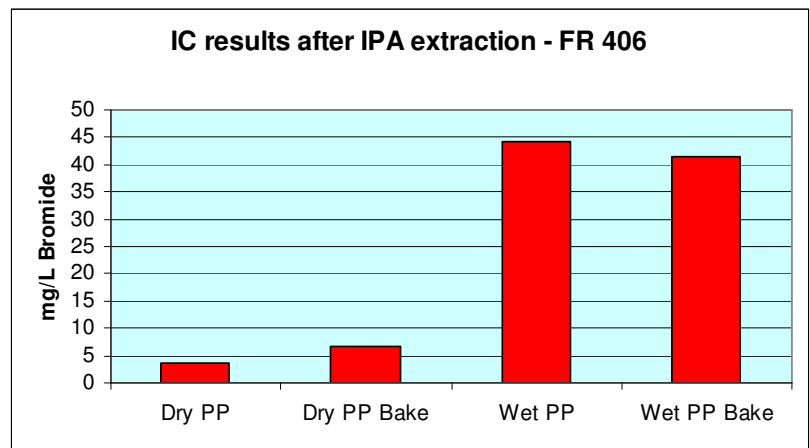
Fig 8

Using IPA extraction and Ion Chromatography we identified the mechanism of the red color change as being caused by high levels of Bromides released from “wet” prepreg during lamination. UV/Vis analysis was used to quantify and compare relative levels of bromides in “wet and “dry” prepreg after lamination. The samples were first baked at 200°C for 140 minutes to accelerate any resin decomposition. The results clearly showed a significant increase in Bromide when “wet” prepreg was used. (Fig 8)

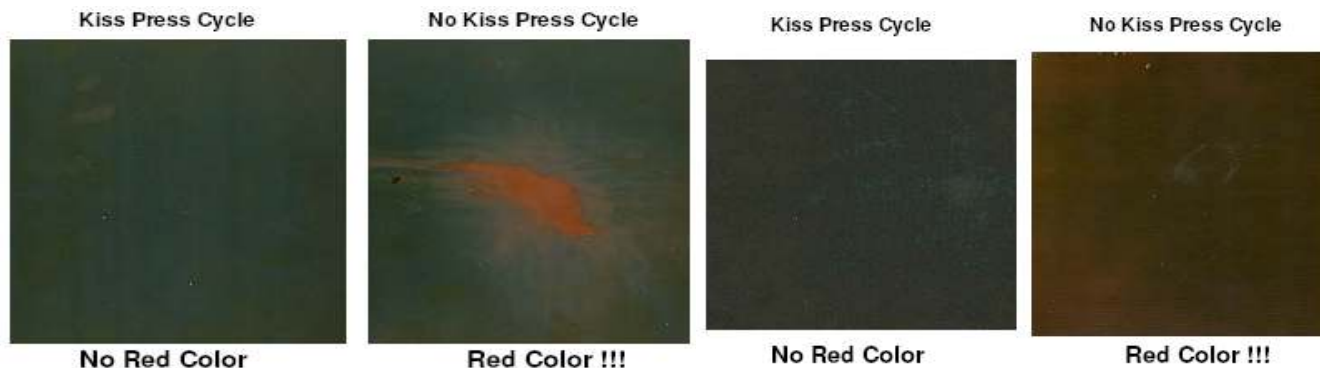
Fig 9 - One Drop of water added before lamination Fig 10 - 72 hours at 280C and 95% relative humidity

Results clearly indicated that using a low temperature “vacuum desiccation” or “kiss” step as the first step in the lamination cycle effectively removed moisture from the package and prevented the red color change caused by trapped moisture (Fig 9 & 10).

1. An initial low temperature 30 minutes “kiss” step, with full vacuum pressure before applying clamping pressure was added, to allow for optimized moisture removal.
2. A standard “no kiss” cycle, with full clamping pressure applied before complete vacuum drawdown.

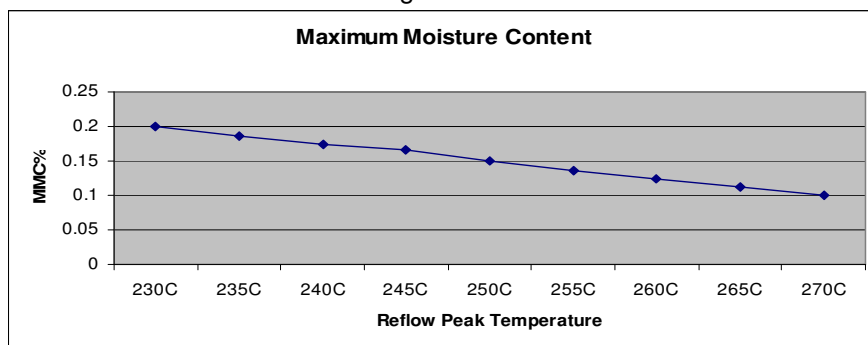
Fig. 11

Subsequent testing has determined that maximum allowable moisture content varies with materials and the intended assembly reflow conditions. Generally 0.1% is considered the maximum for lead-free assembly. Certainly moisture content above 0.2% has shown to cause significant performance and delamination problems (Fig. 11).
